Appendix A

Photo Logs

Facility Siting General Photolog

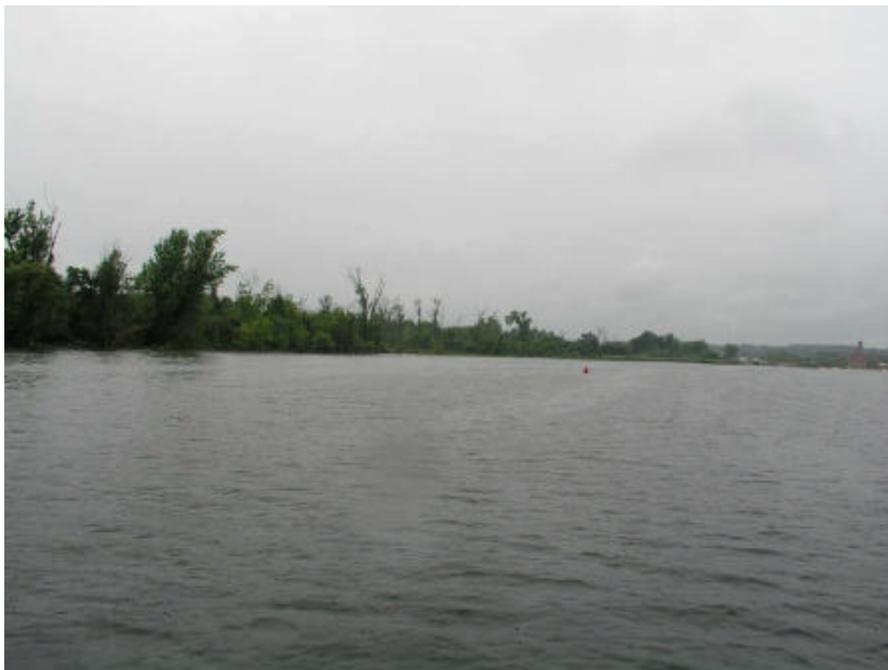
View to southeast of site from Hudson River (08/01/03).

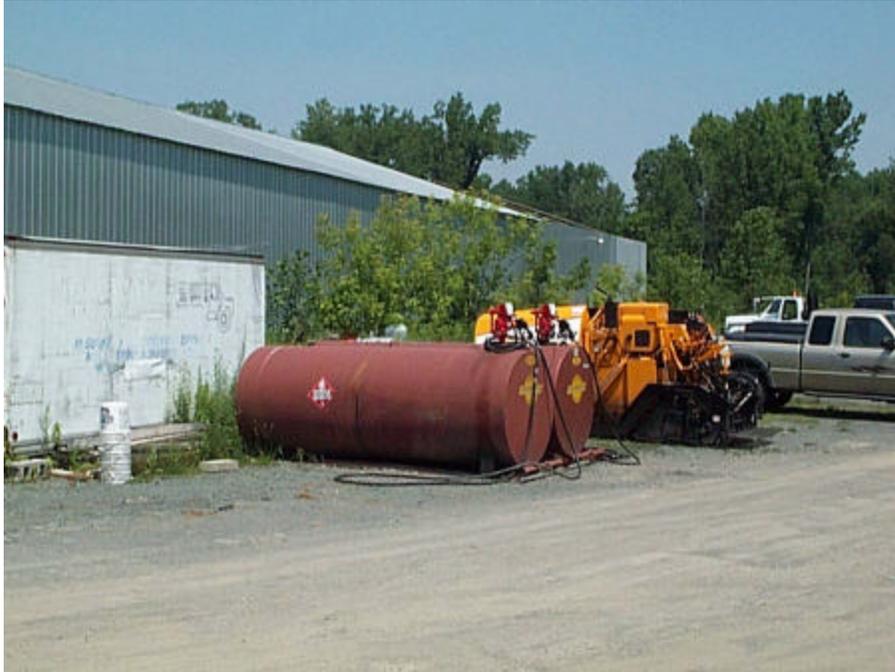
View to northwest of ASTs at Brickyard facility near surface soil BBA-SS02 (07/24/03).

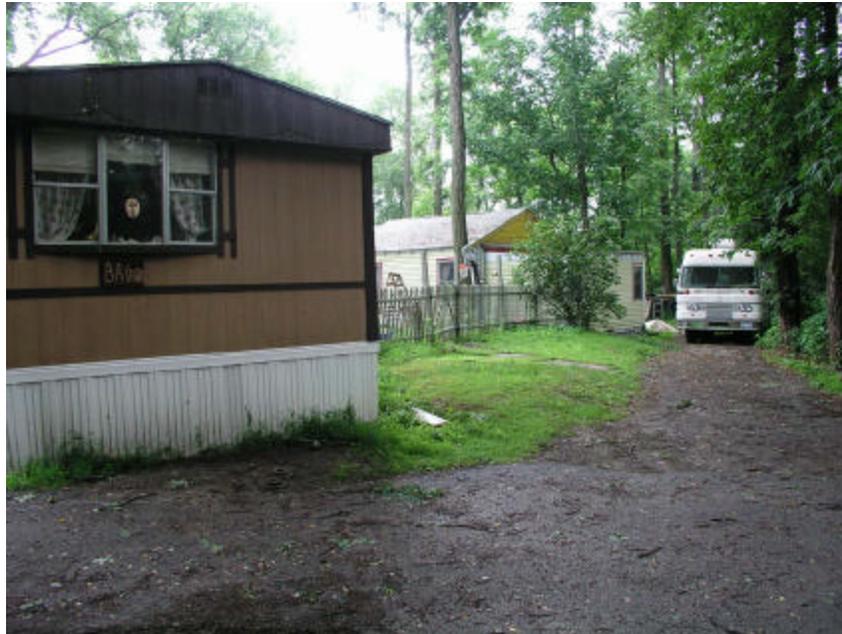
View to southeast of residences located in southeastern portion of property (07/23/03).

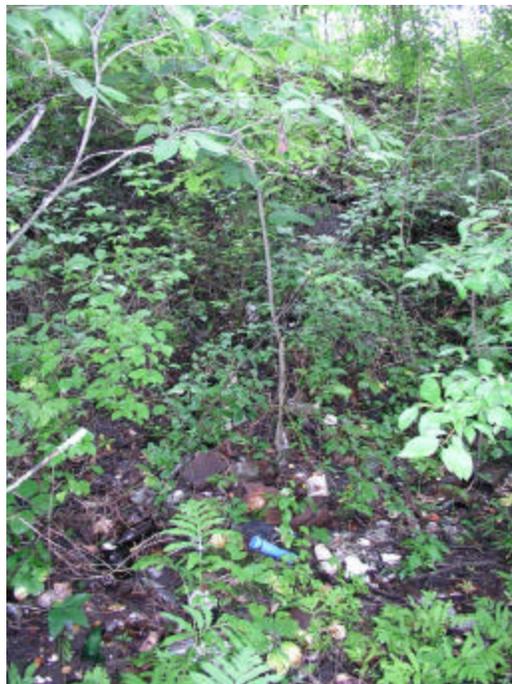
View to south dump located near the east-central portion of property (07/23/03).

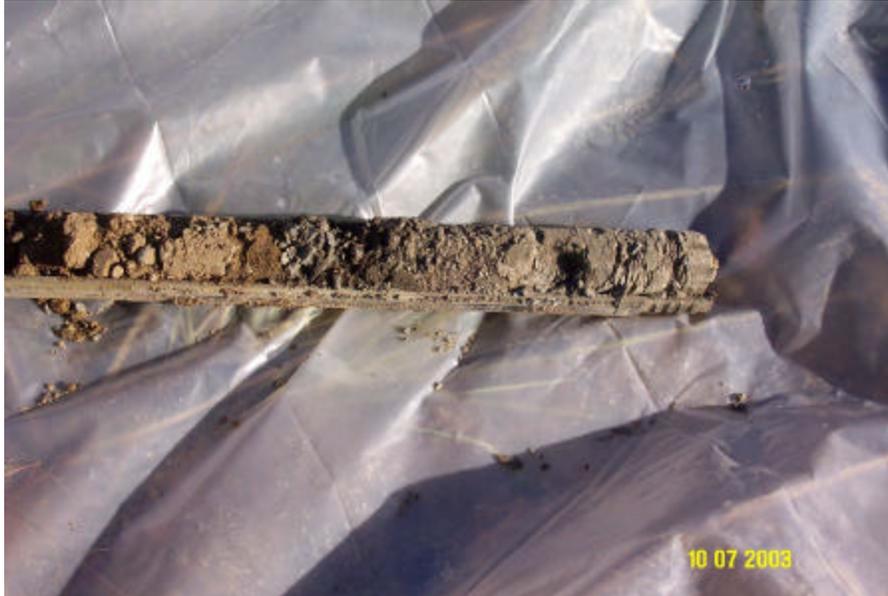
Split-spoon from boring NCC-GT01 (10/07/03).

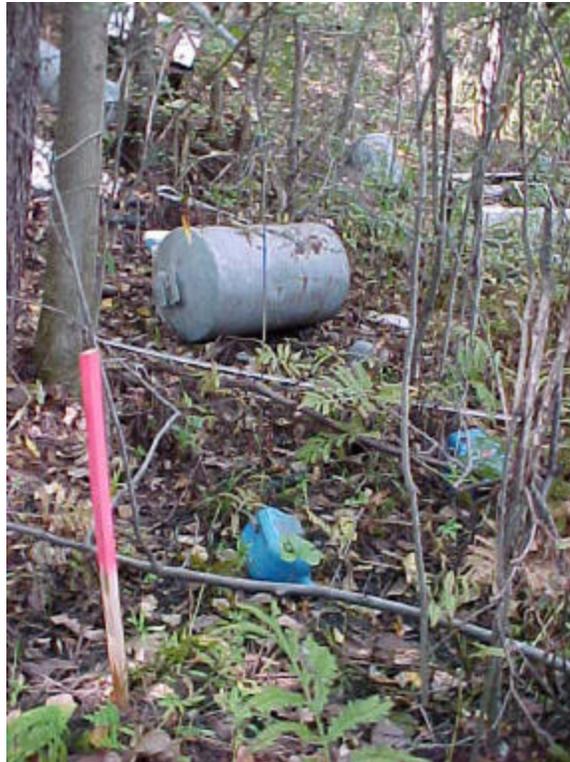
Debris and waste near surface soil sample location NCC-SS04 (10/02/03).

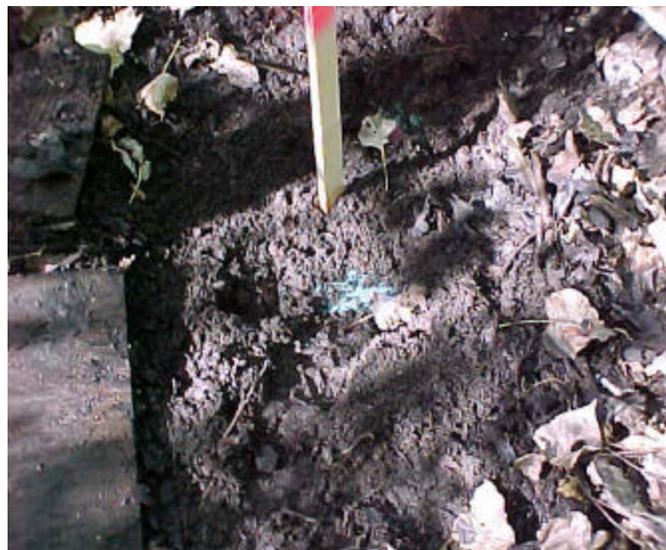
Material underlying surface soil sample location NCC-SS06 (10/02/03).

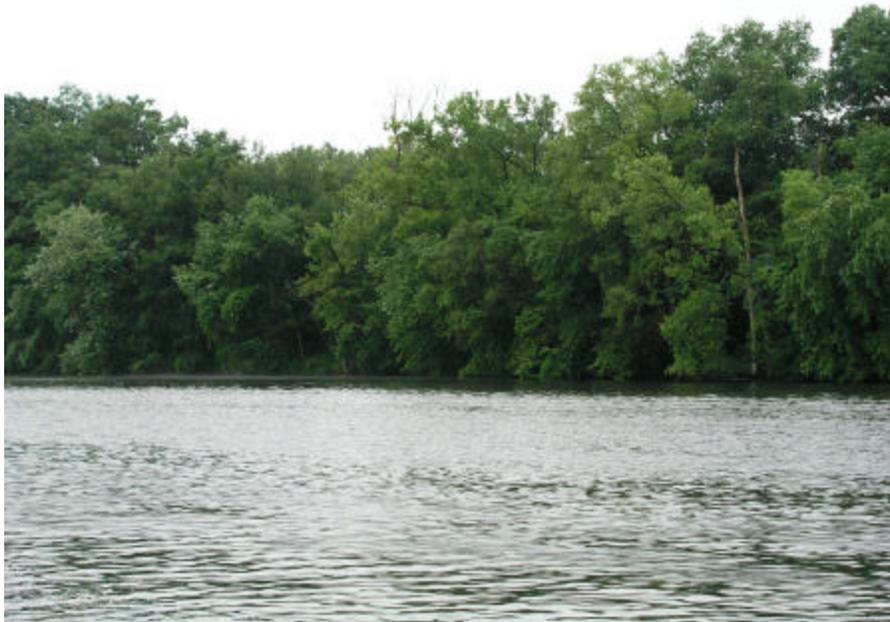
View to west of NYS Canal Corp. site from Hudson River (08/01/03).

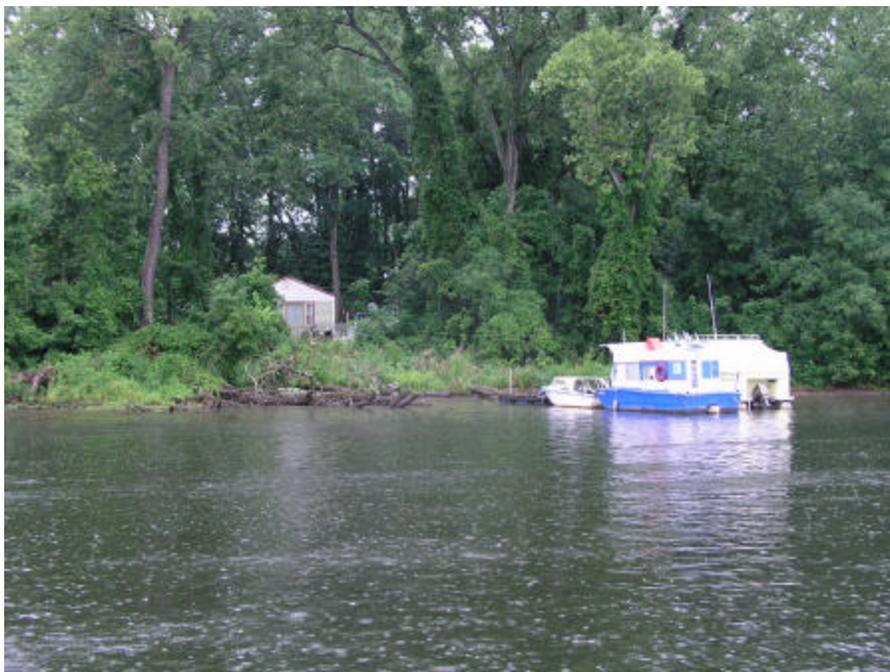
View to west of southern end of NYS Canal Corp. site from Hudson River (08/01/03).

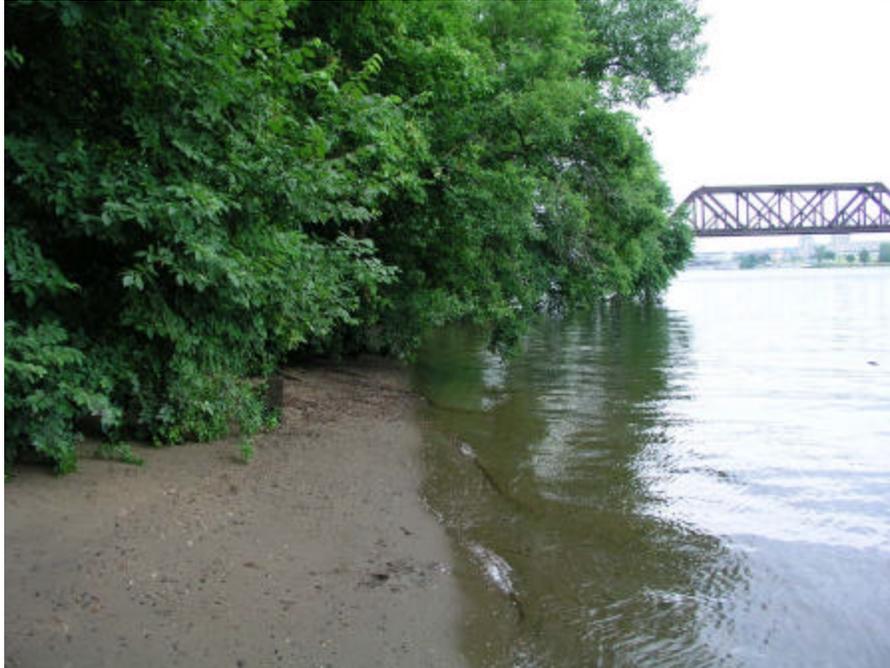
View to south (downstream) of shoreline (07/17/03).

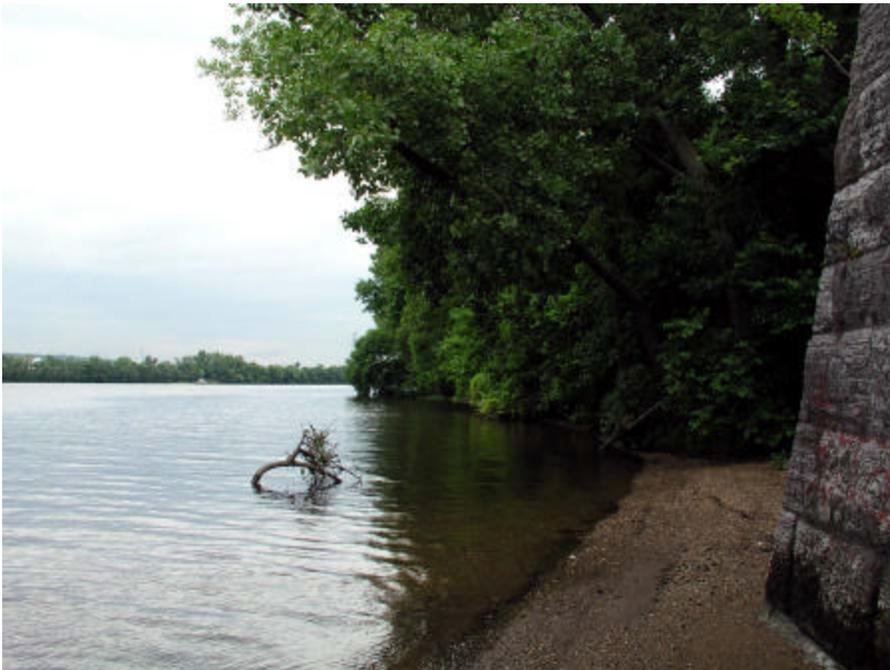
**View to north (upstream) of shoreline from train bridge abutment
(07/17/03).**

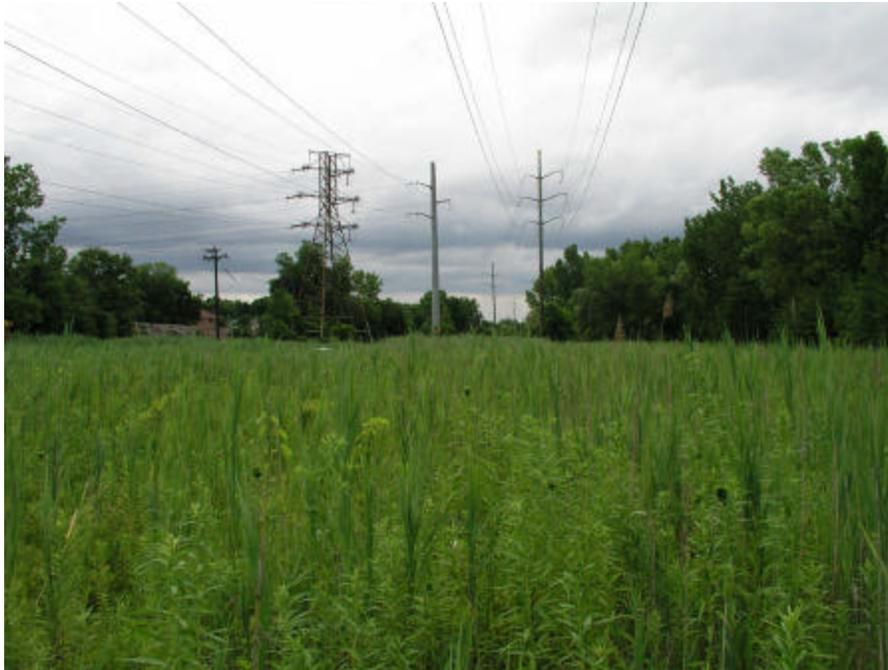
View to north of Niagara Mohawk right-of-way on OG Real Estate property (07/22/03).

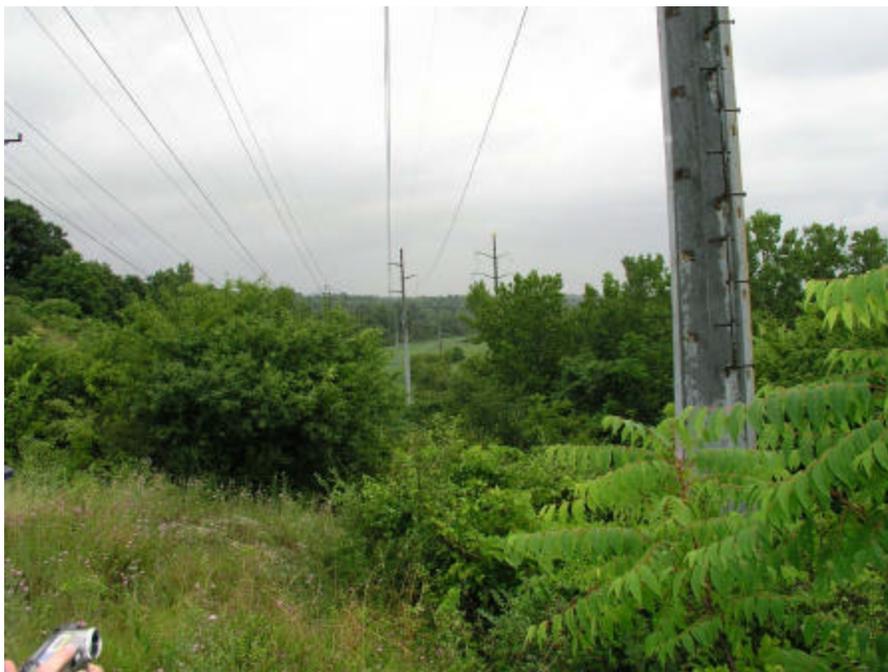
View to north of Niagara Mohawk power lines from southwest corner of the site (07/22/03).

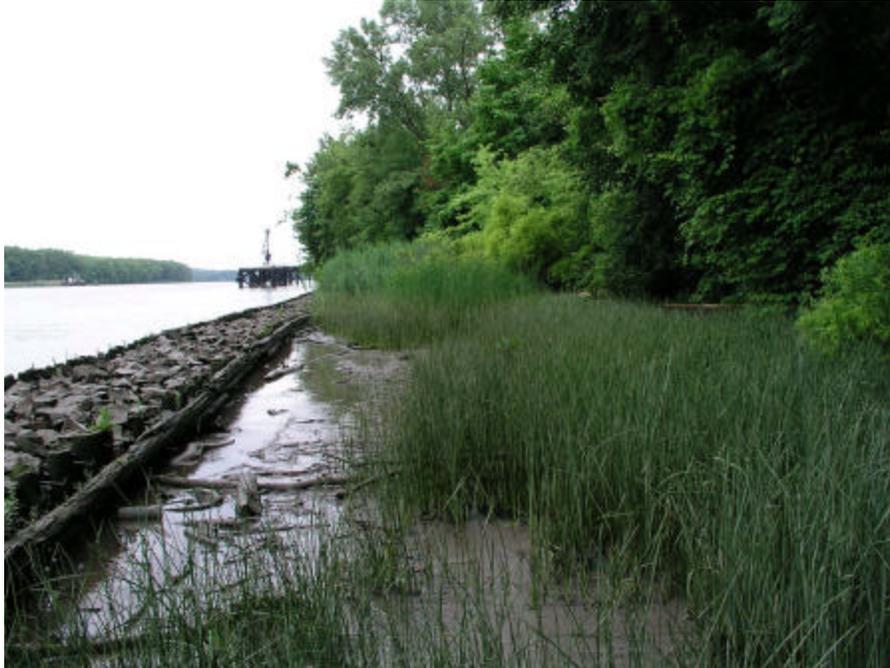
View to southeast (downstream) of shoreline with riprap breakwall (07/22/03).

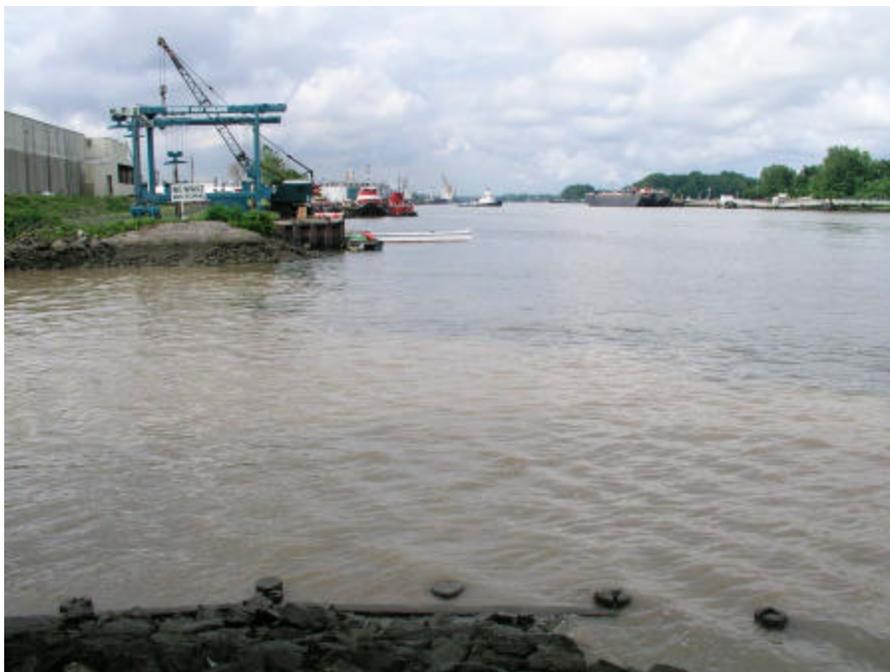
View to north of Albany Port from northeast corner of site (07/22/03).

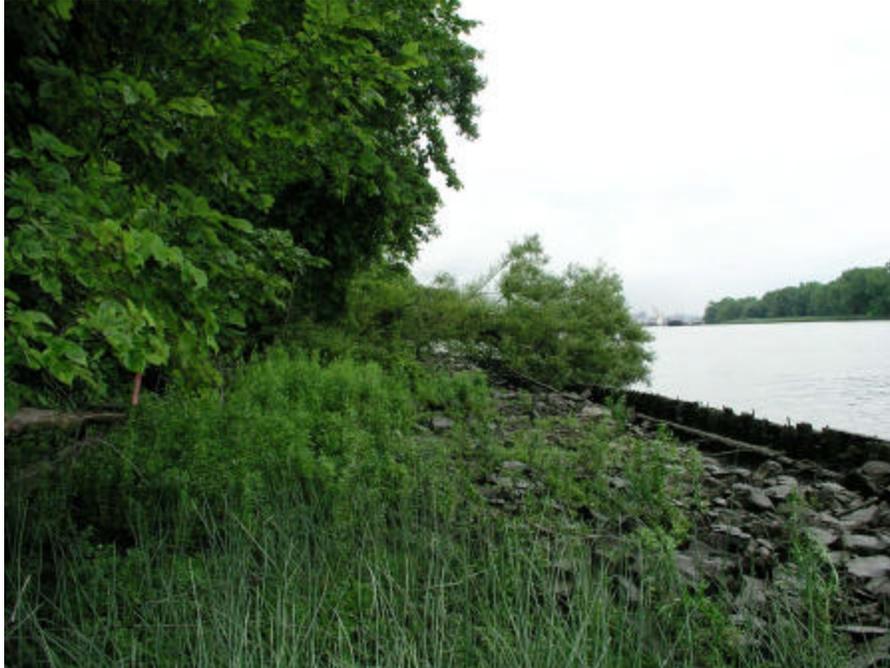
View to north of shoreline from southern portion of site (07/22/03).

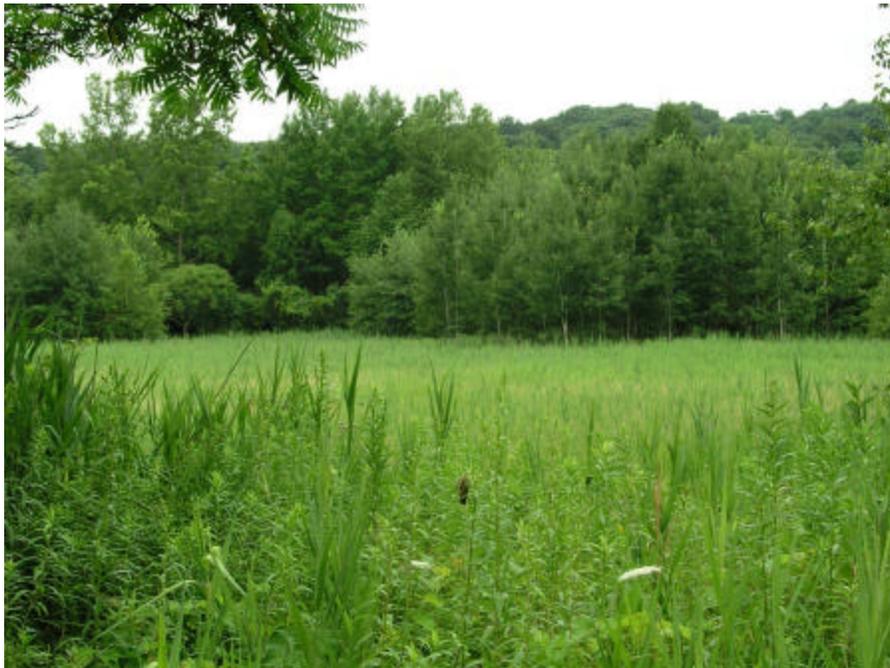
View of typical fragmites covering most open areas (07/22/03).
